WL-TR-91-4032
DOT/FAA/CT-91/23
VOL II, Part 2

COMPOSITE FAILURE ANALYSIS HANDBOOK
VOL II - TECHNICAL HANDBOOK
PART 2 - ATLAS OF FRACTOGRAPHS

R.J. Kar
Northrop Corporation
One Northrop Avenue
Hawthorne, California 90250-3277

February 1992

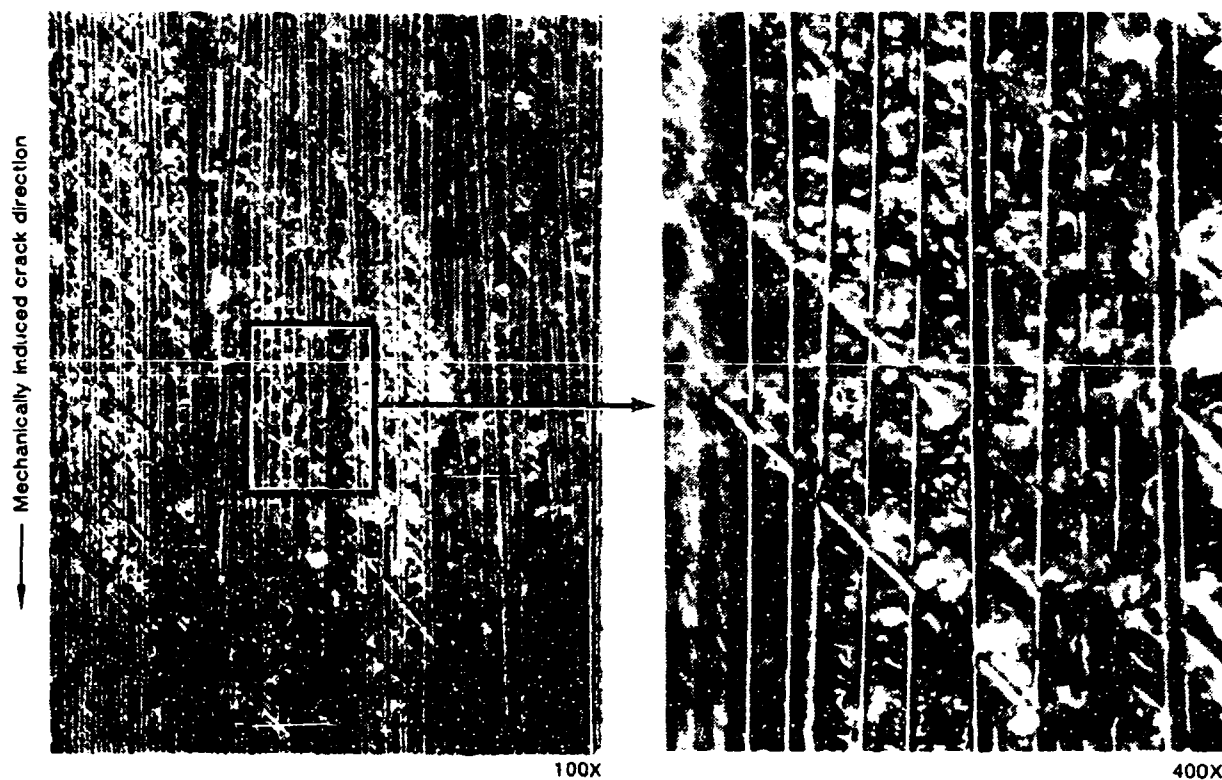
Fracture type	Interlaminar mode II shear
Ply layup	[0, 45] _{12S}
Test type	ENF
• Test conditions	21°C, dry
• Fracture between	0/45 plies
Material	Hercules 3501-6/177°C cure AS4 fibers

Figure 2-71. Photographs of Interlaminar Mode II Shear, 0/45 Fracture, 70 F/Dry

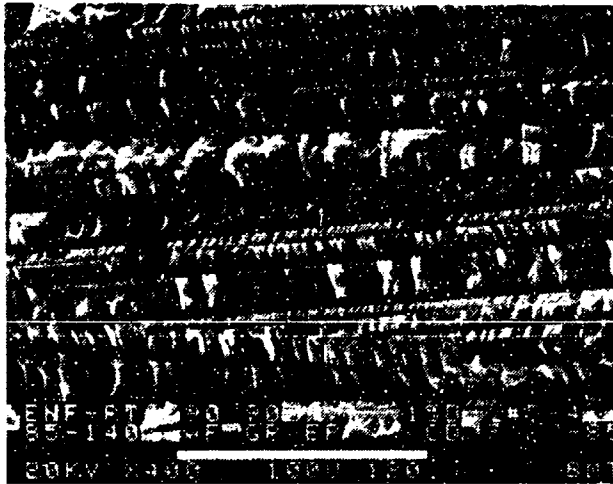
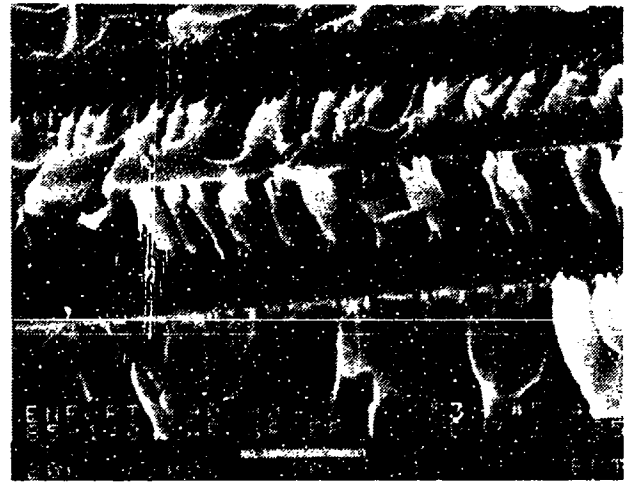
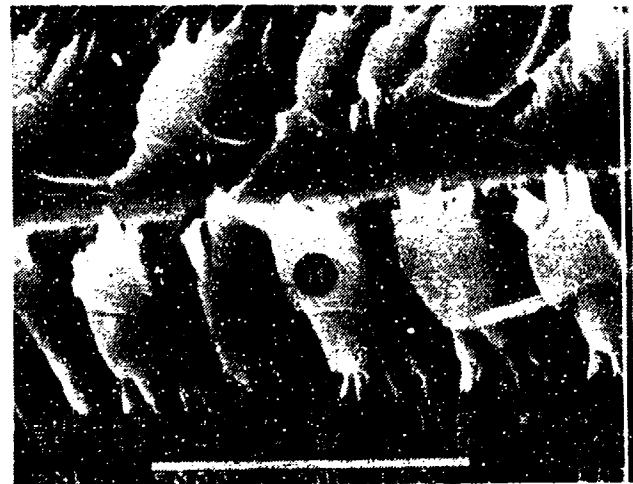
Fracture type	Interlaminar mode II shear
Ply layup	[90] 24
Test type	ENF
• Test conditions	21°C, dry
• Fracture between	90/90 plies
Material	Hercules 3501-6/177°C cure AS4 fibers

Mechanically Induced crack direction

Figure 2-75. SEM Photographs of Interlaminar Mode II Shear, 90/90 Fracture, 70 F/Dry

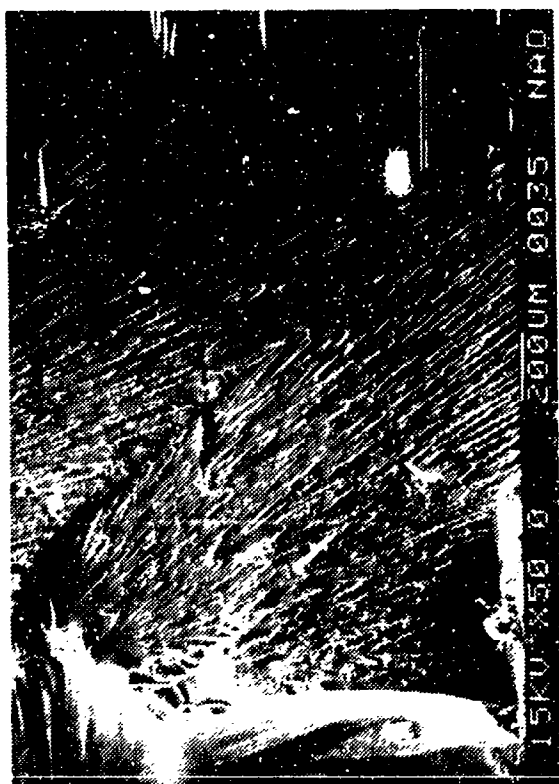
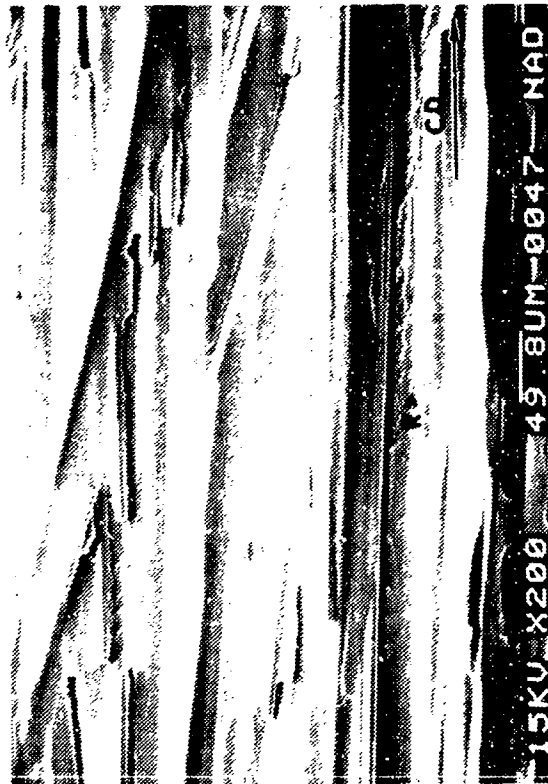
Figure 2-76. Optical and SEM Photographs of Mode II ENF Interlaminar Shear Fracture in Filament Wound Gr/Ep - [0] _{24T}, Room Temperature Ambient
(a) Macro photograph
(b) Low Magnification SEM Photograph of Initiation
(c) River Patterns at Larger Crack Lengths

CD = Crack-propagation direction
R = River patterns

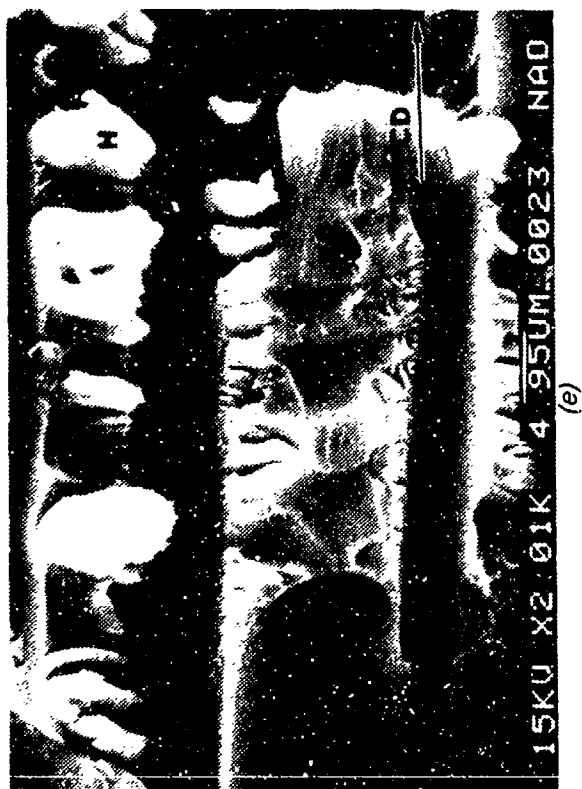
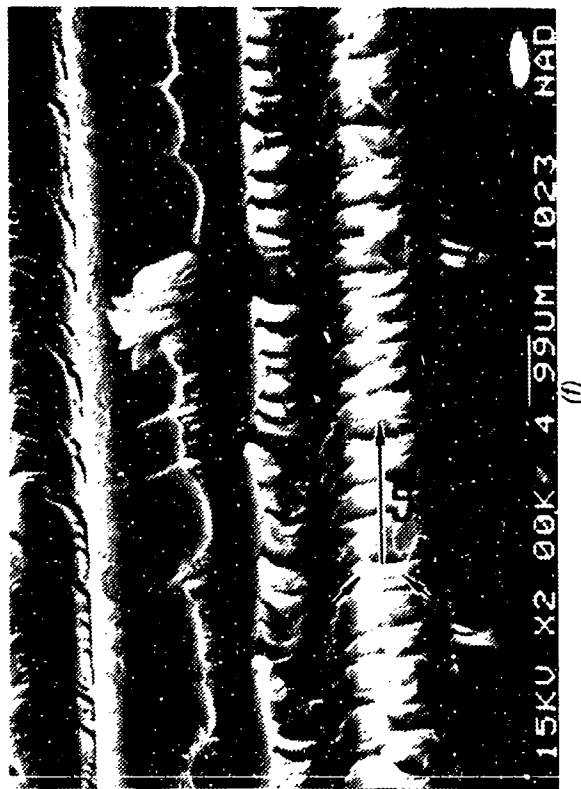
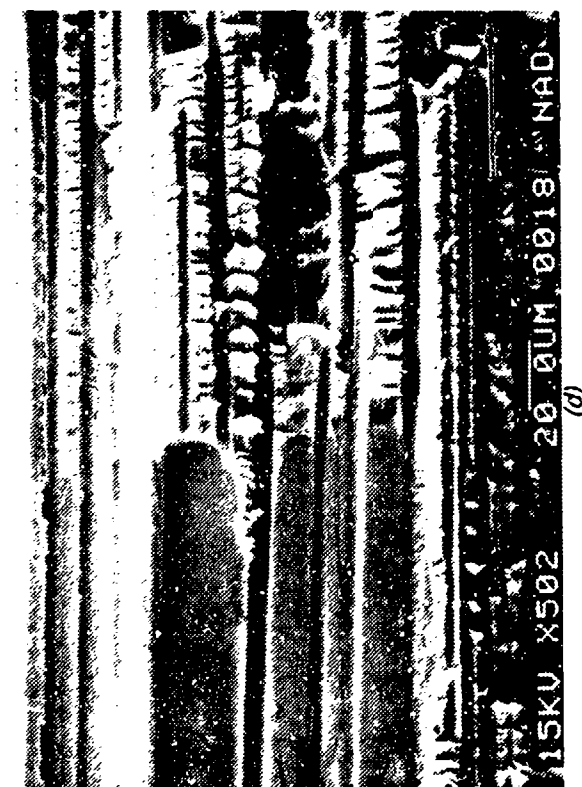
Figure 2-76. (Continued)
 (d) Region I/Region II Boundary
 (e) Hackles (H) and Scallops (S) in Region II
 (f) River Patterns (R) at Roots of Hackles

CD = Crack-propagation direction

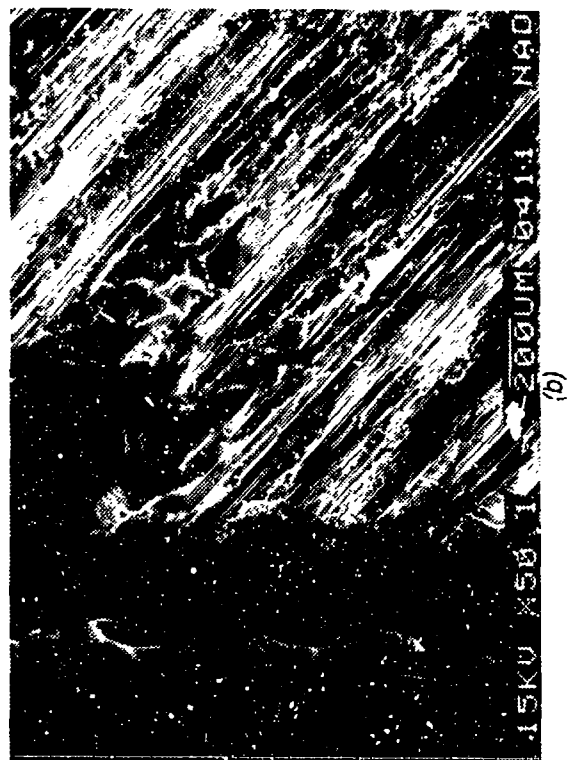
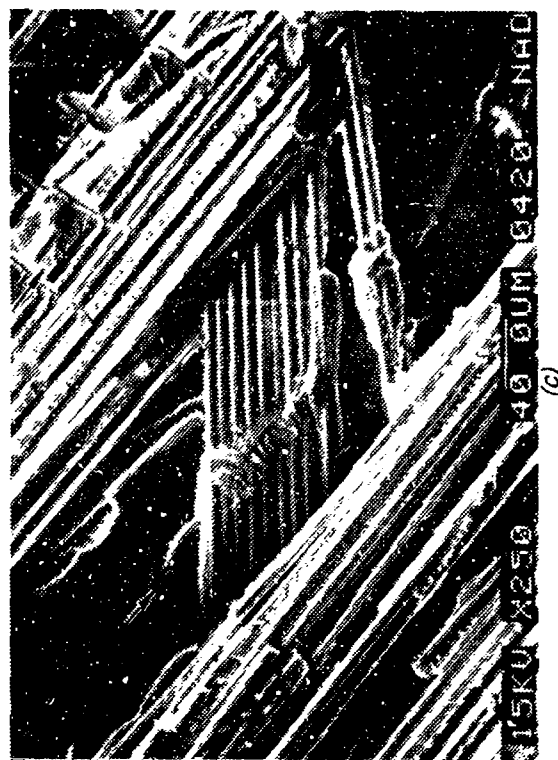
Figure 2-77. Optical and SEM Photographs of Mode II ENF Interlaminar Shear Fracture in Filament Wound Gr/Ep - [J45/0/-45]_{4s}, Room Temperature Ambient

(a) Macro photograph of Fracture

I = Precrack, II = Crack-growth region, III = Laboratory overload

(b) Fracture Initiation in Region I

(c) River Patterns (Arrows) in Region I

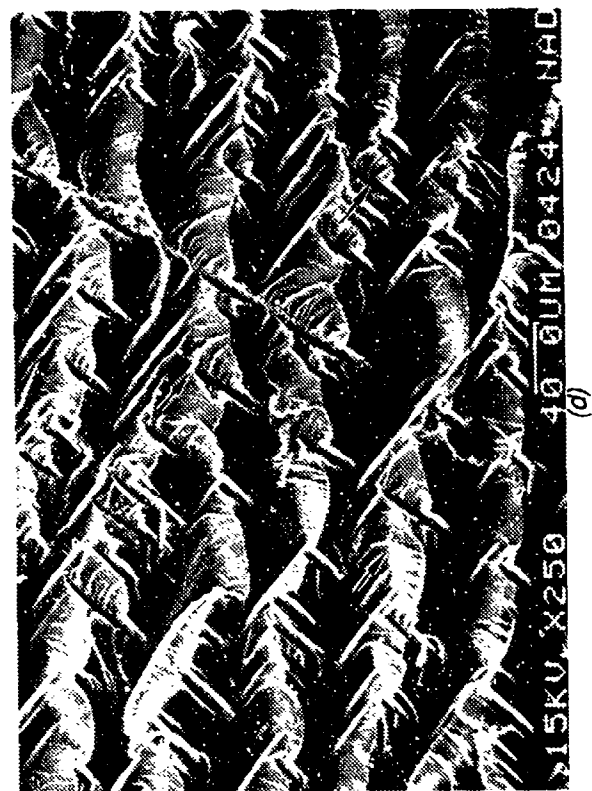
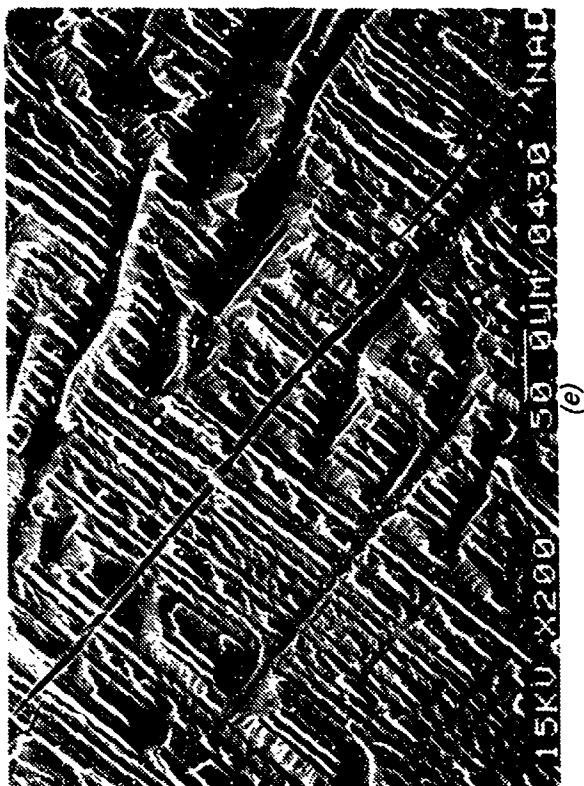
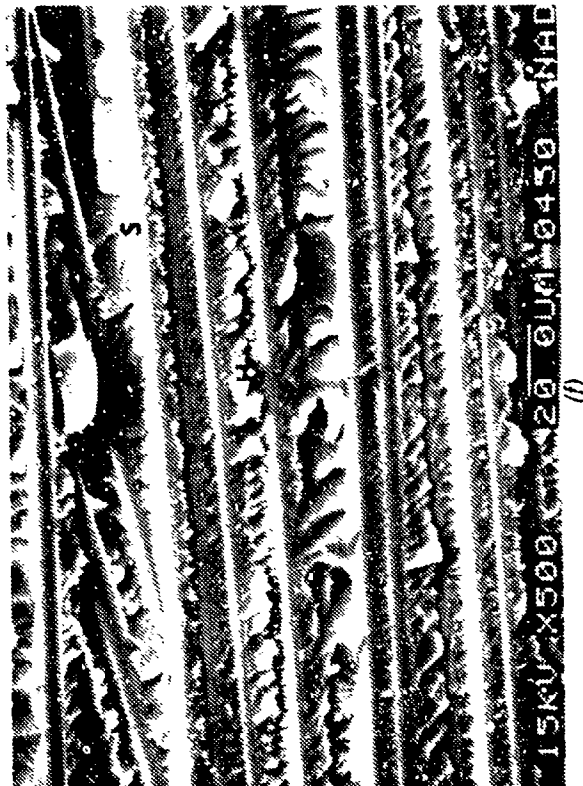
Figure 2-77. (Continued)
 (d) River Patterns (Arrows) in Resin Between 0 and 45 Degree Plies
 (e) Cracks in Ply
 (f) Hackles (H) and Scallops (S) in Mode II Shear Region

CD = Crack propagation direction

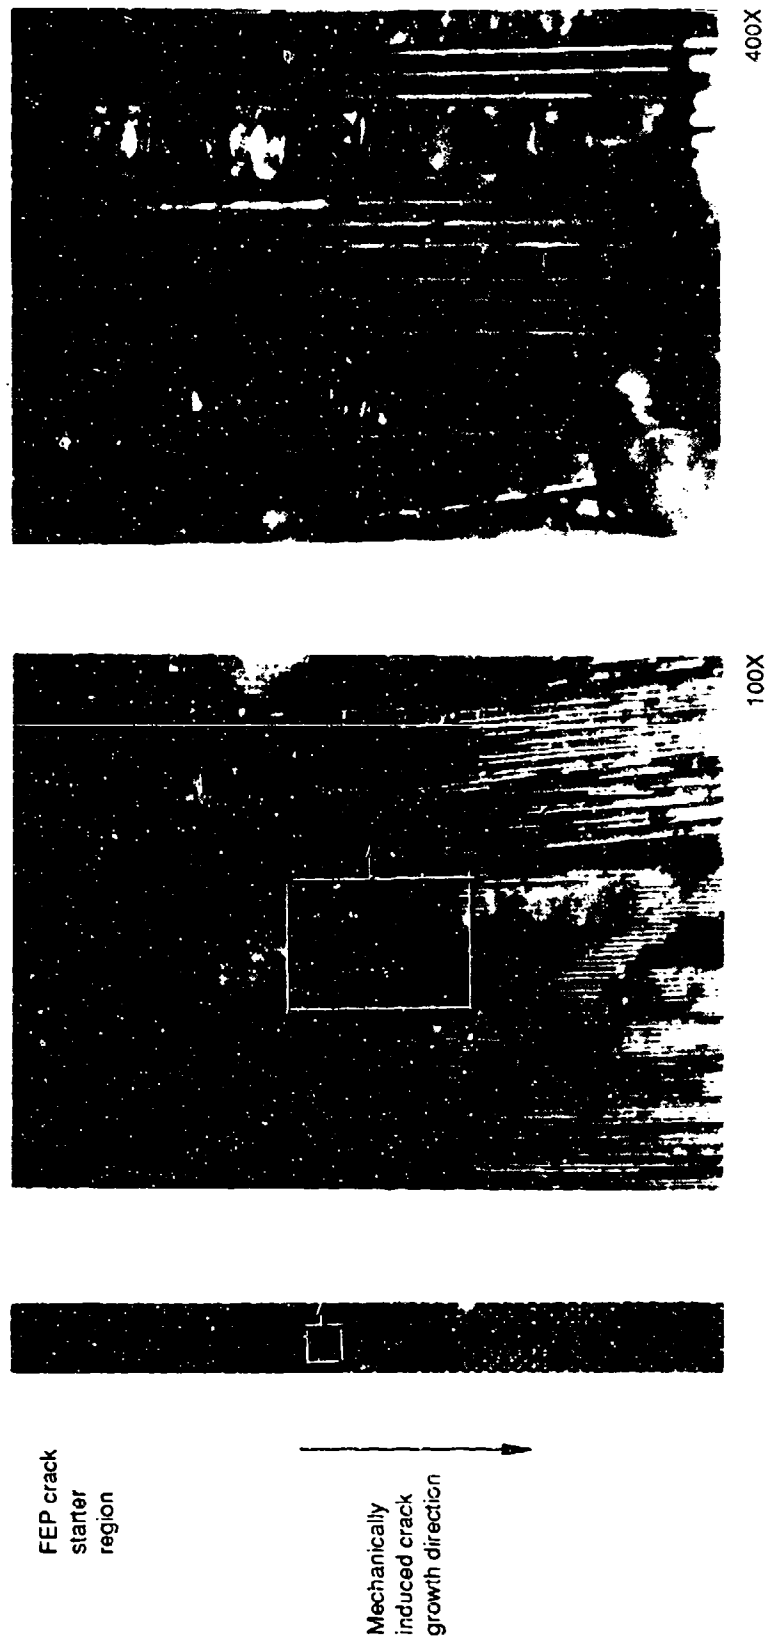
Figure 2-78. Optical Photomicrographs of Interlaminar Mode II Shear, Room Temperature, 0/90 Fabric Fracture

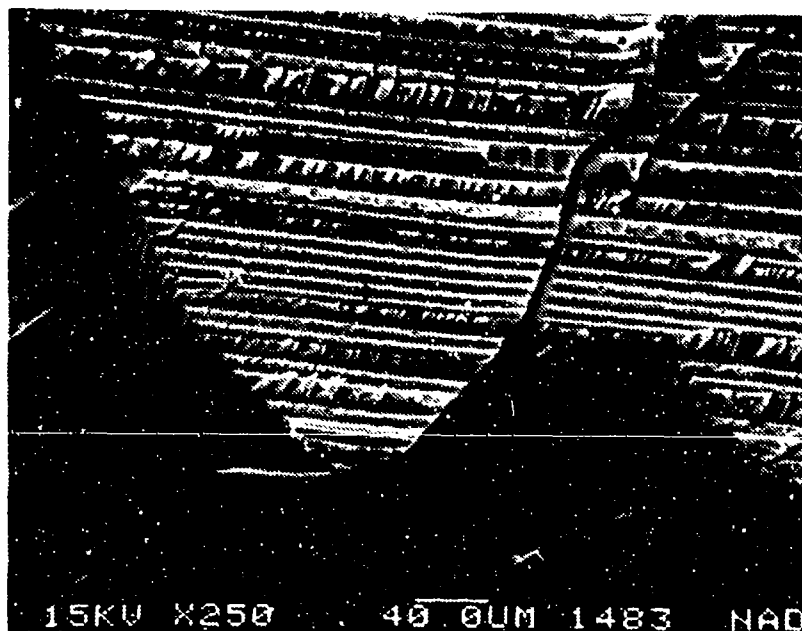
Figure 2-80. SEM Photograph of Mode II ENF Interlaminar Shear Fracture in 3-D Weave Gr/Ep - [+45/0/-45]_{4S} in Crack-Growth Region

Note: Arrows indicate mixed-mode interlaminar fracture features.

P = Resin pocket adjacent to weave

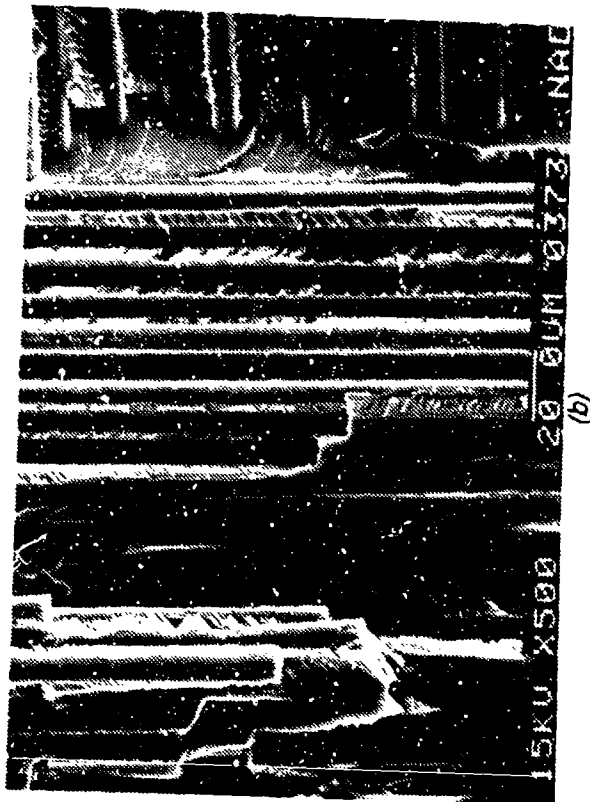
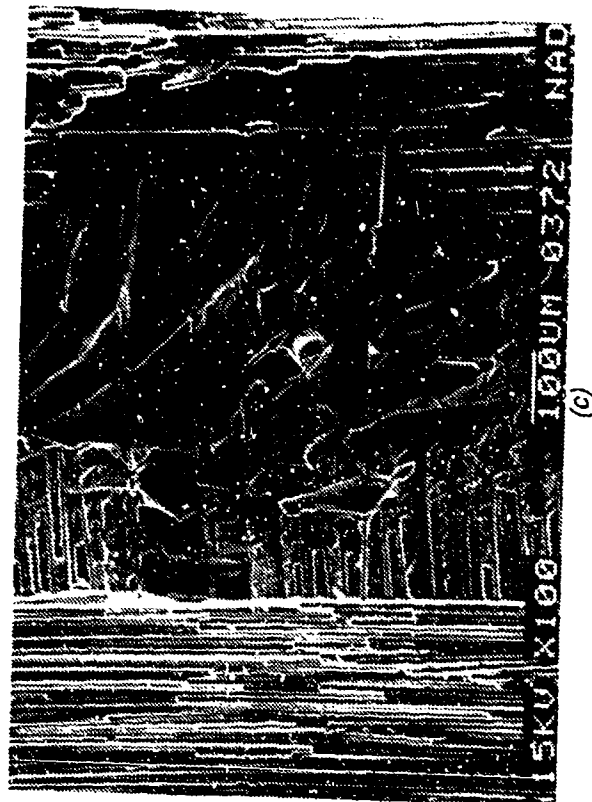
Figure 2-81. Optical and SEM Photographs of Mode II ENF Interlaminar Shear Fracture in Gr/Ep - [0/90]ss, Impact Damaged Before Test
 (a) Macrograph of Fracture
 (b) Local Fracture in 90 Degree Ply in Region I (Arrow)
 (c) River Patterns in 0 Degree Ply in Region I (Arrow)

CD = Crack propagation direction

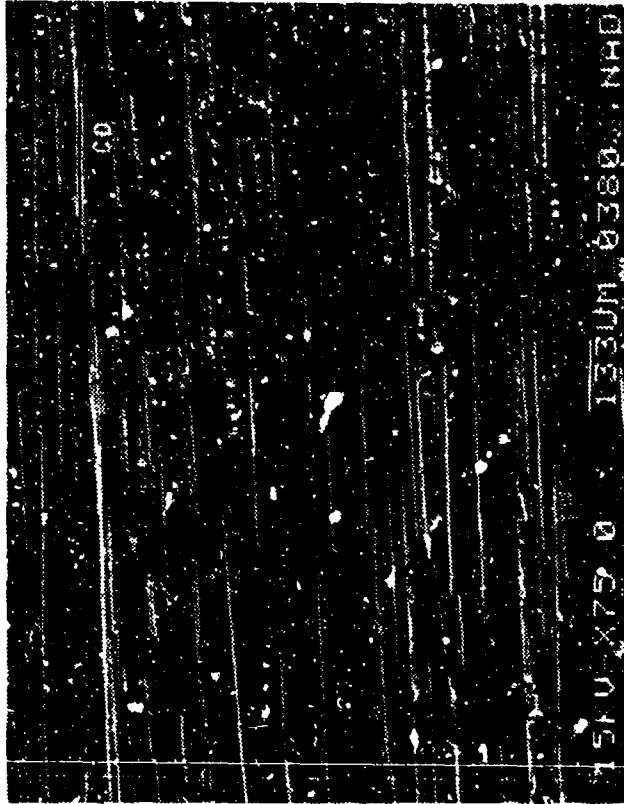
Figure 2-81. (Continued)
 (d) Interface Between Mode I (T), Mode II (S), and Impact (I) Fracture Areas
 (e) Mode I/Mode II Interface Regions
 CD = Crack propagation direction

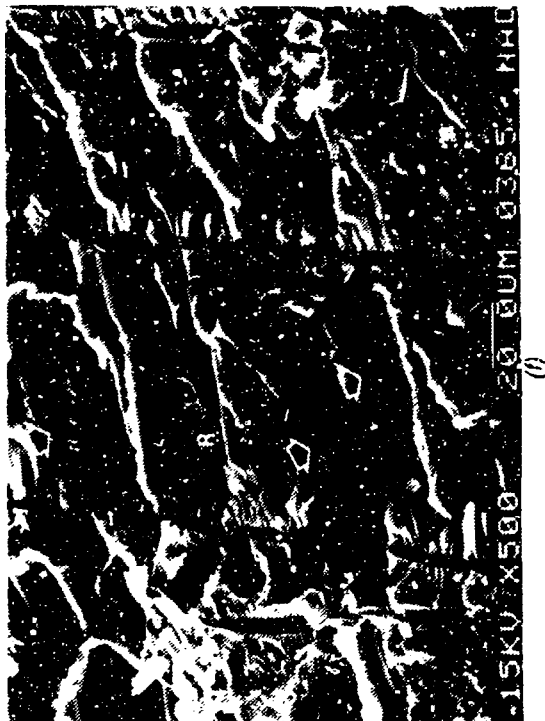
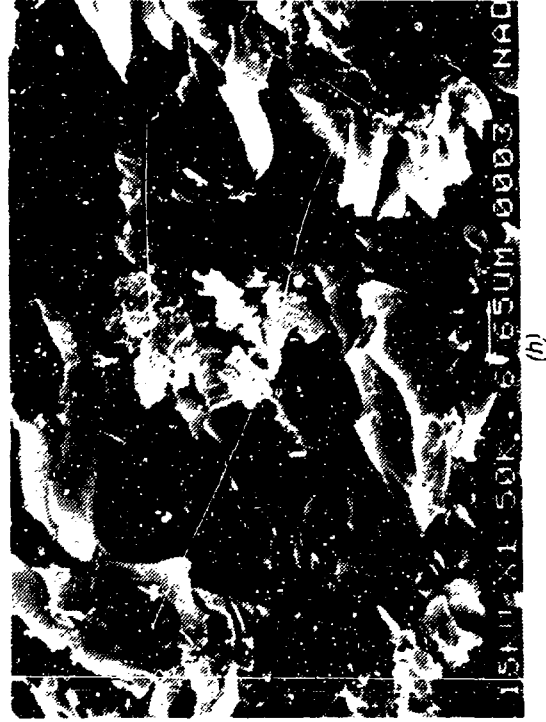
Figure 2-81. (Continued)
 (i) Smooth Resin Surface With River Patterns (R) and
 Crushed Resin (C) in Impacted Region
 (g) Hackles (H) and Delamination Fracture in Impact
 Area
 (h) Details of Delamination Fracture Shown in (g)
 Note river patterns oriented along CD
 CD = Crack propagation direction

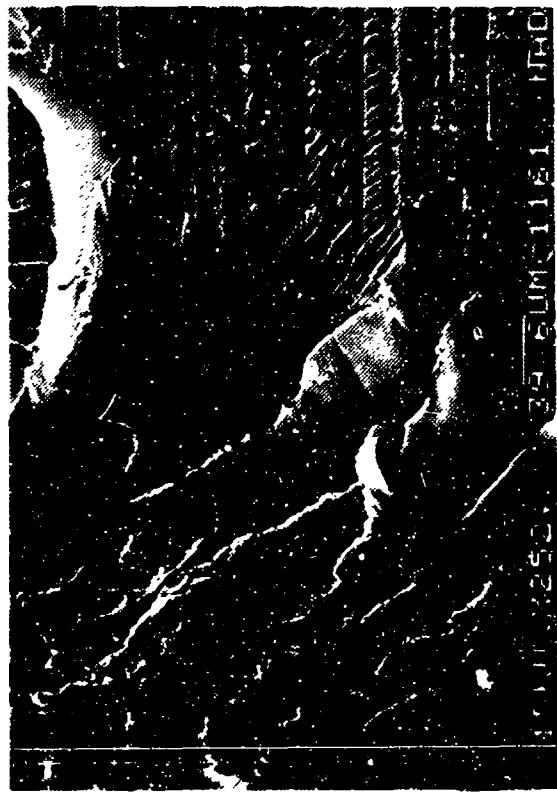
Figure 2-82. Optical and SEM Photographs of Mode II ENF Interlaminar Shear Fracture in Gr/Ep - [0] _{24T} Water Immersed Before Test

- (a) Macro photograph
- (b) Initiation in Precrack Region
- (c) Details of Initiation

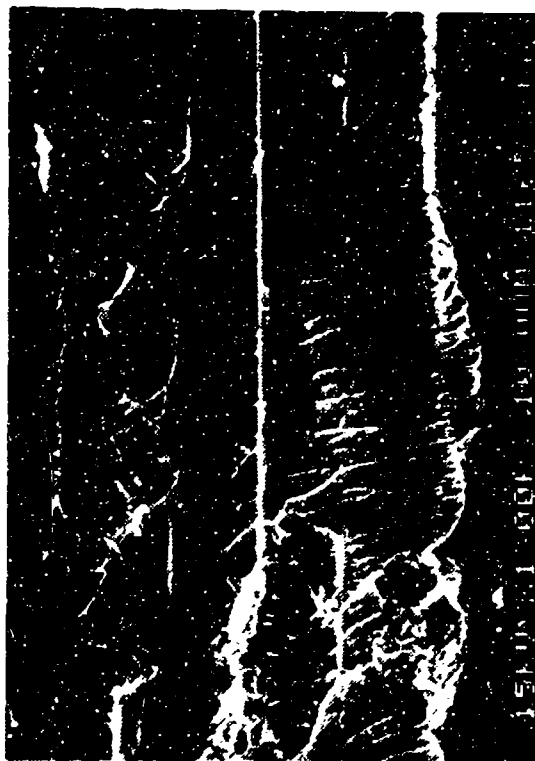
Figure 2-82. (Continued)
 (d) River Patterns in Region I
 (e) Region I/II Interface
 (f) Hackles in Region II

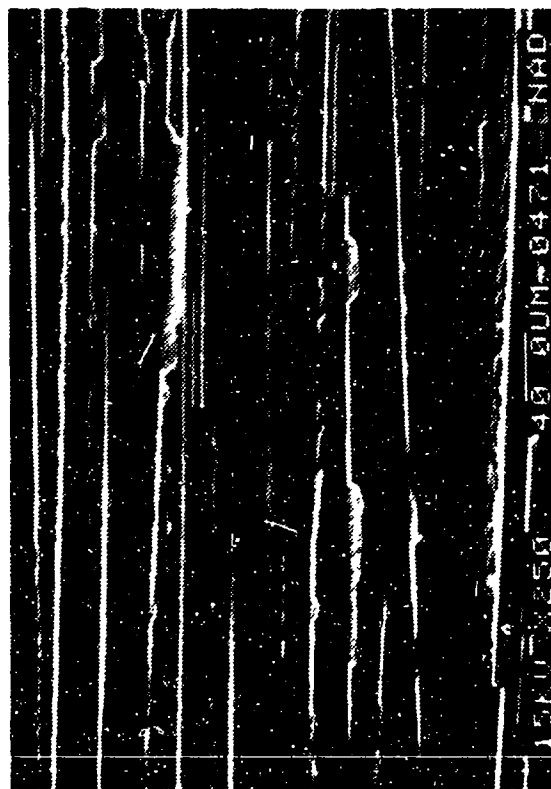
Figure 2-83. Optical and SEM Photographs of Mode II ENF Interlaminar Shear Fracture in Gr/Ep - [0°/90] es. Water immersed Before Test
(a) Macro photograph Showing Regions I, II, and III (Precrack, Mode II Shear, and Laboratory Overload)
(b) Initiation Occurring at Resin-Rich Areas Adjacent to Armalon (A) Insert
(c) River Patterns (Arrows) in Mode I Fracture

CD = Crack propagation direction

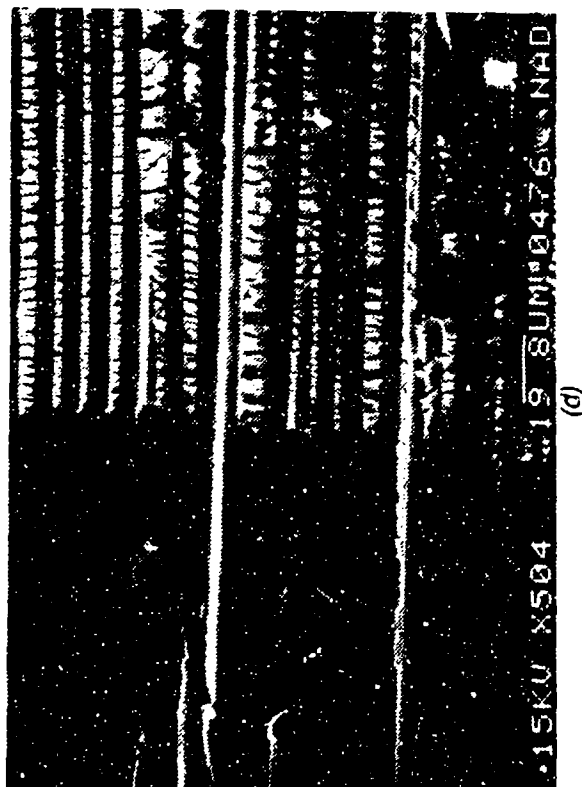
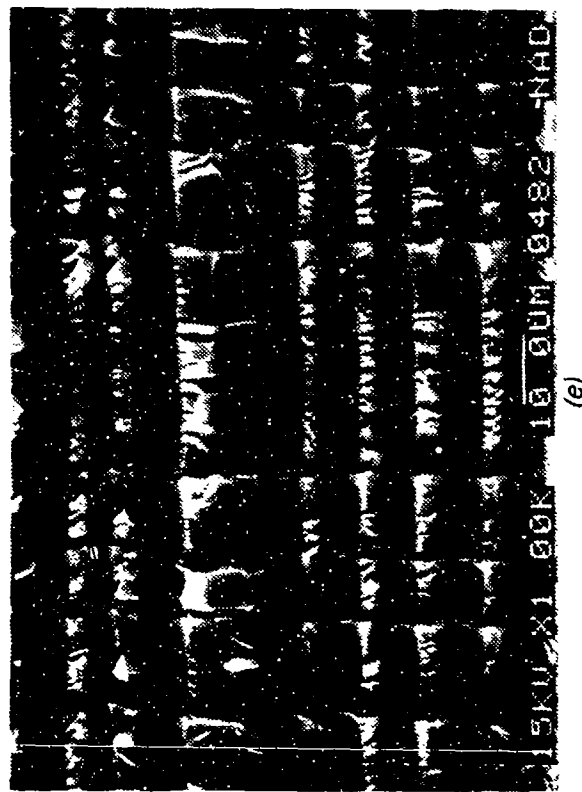
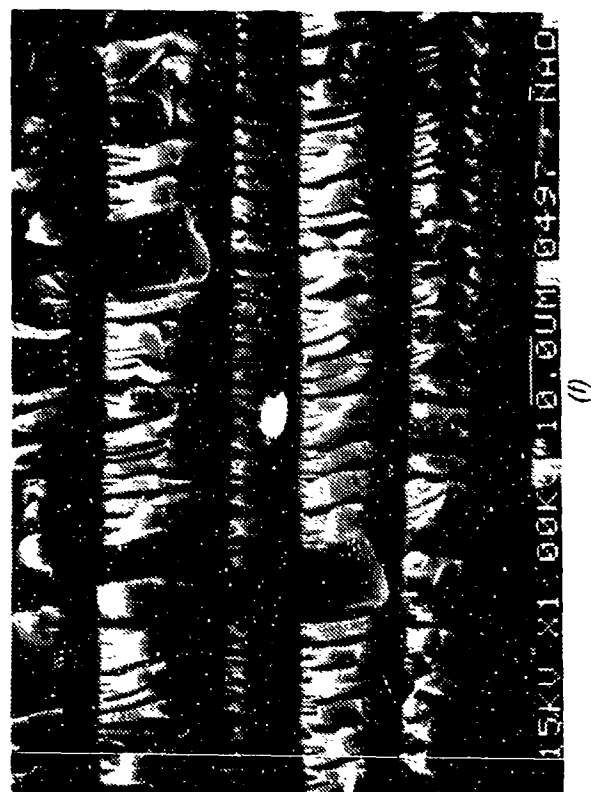
Figure 2-83. (Continued)
 (d) Mode I/Mode II Interface
 (e) Cracks Found in Mode II Fracture Region
 (f) Mode II Hackles (H) and Scallops (S)

CD = Crack propagation direction

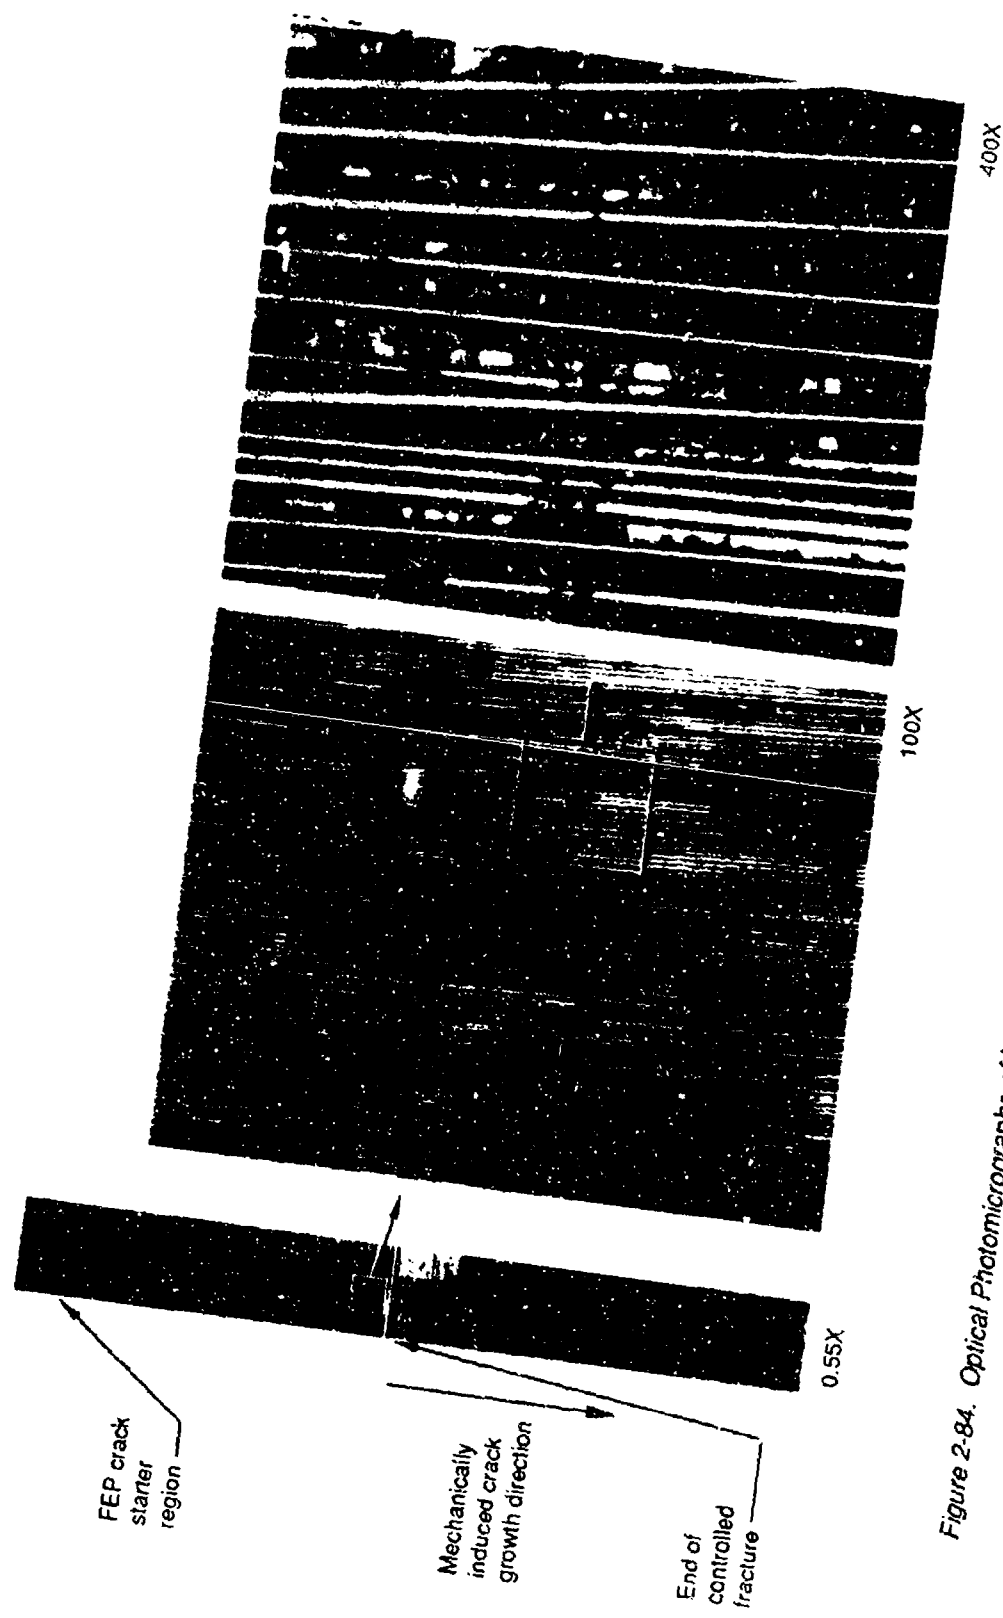
Figure 2-84. Optical Photomicrographs of Interlaminar Mode II Shear, 0/90 Fracture, Water Immersion (160 F) After Test

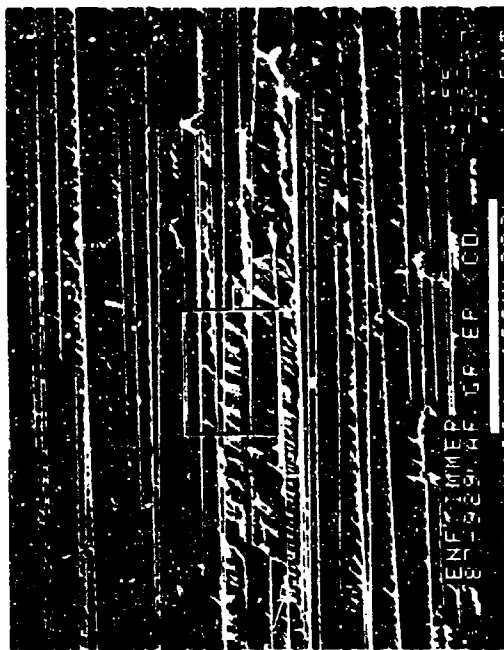
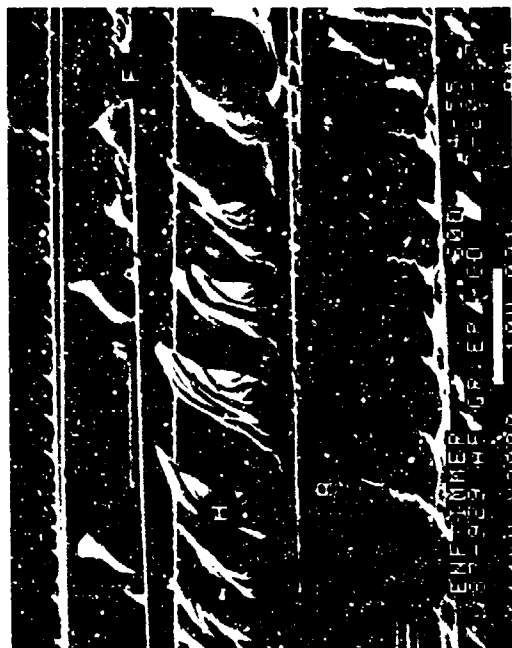
- F fiber matrix separation
- H hackles
- R rivermarks

Figure 2-85. SEM Fractographs of Interlaminar Mode II Shear, 0/90 Fracture, Water Immersion (160 F) After Test

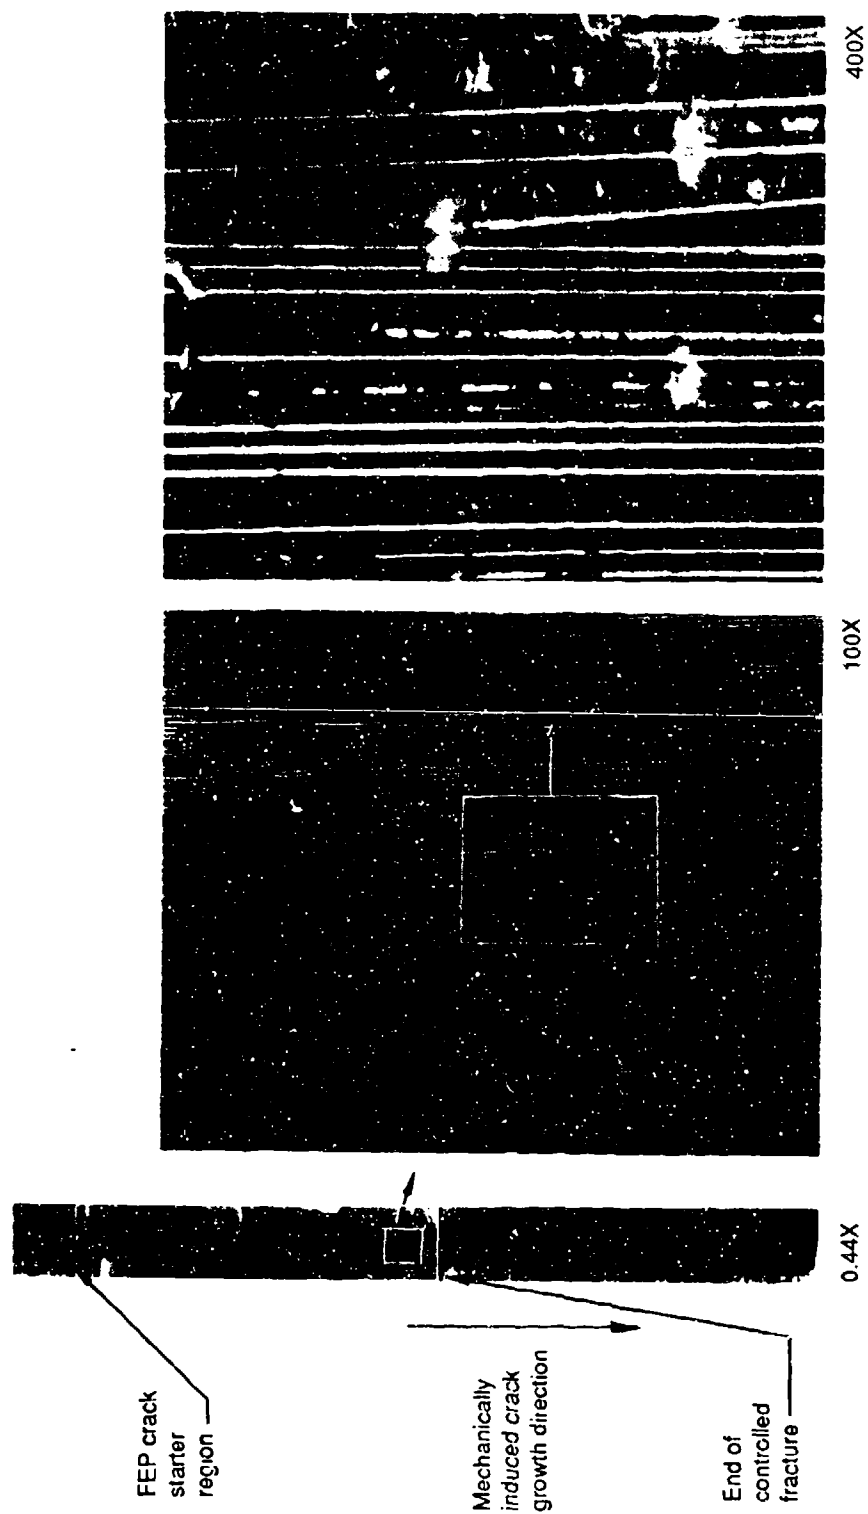
Figure 2-86. Optical Photomicrographs of Interlaminar Mode II Shear, 0/90 Fracture, Exposure to Humidity (160 F) After Test

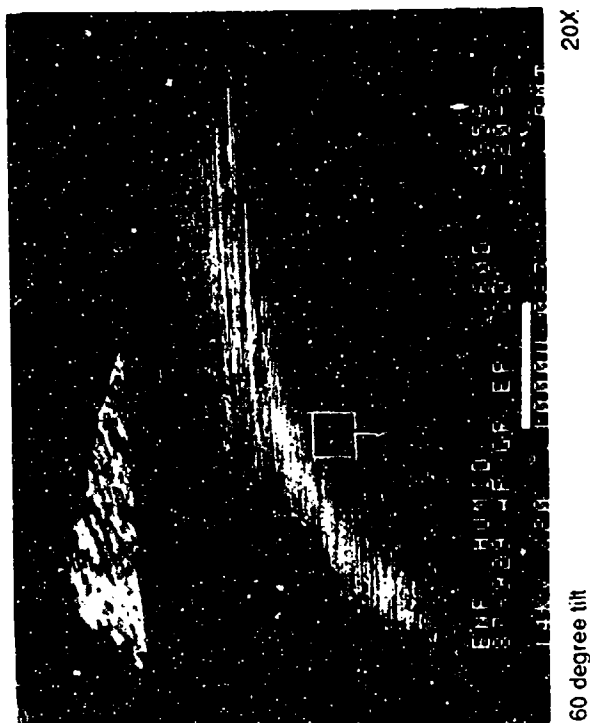
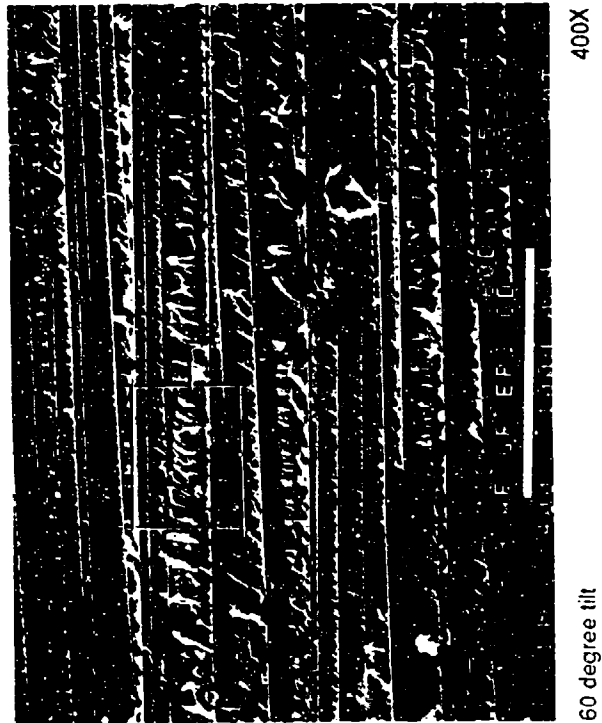
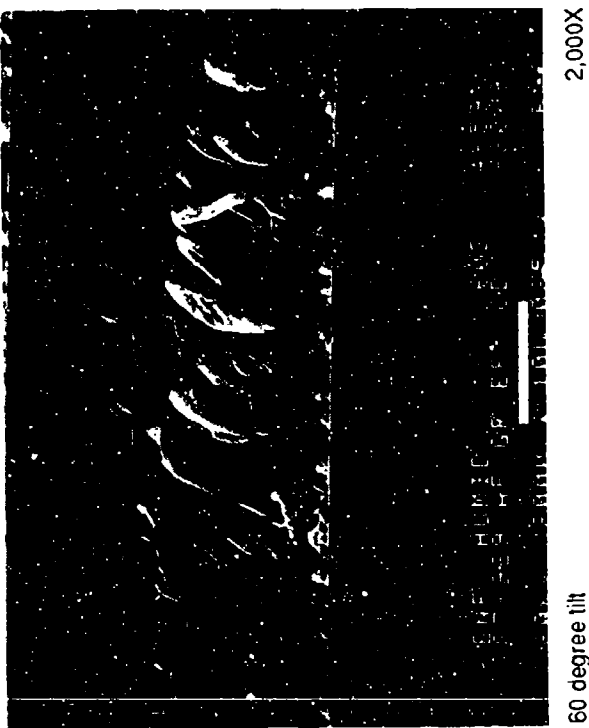
F fiber matrix separation

Figure 2-87. SEM Fractographs of Interlaminar Mode II Shear, 0/90 Fracture, Exposure to Humidity (160 F) After Test

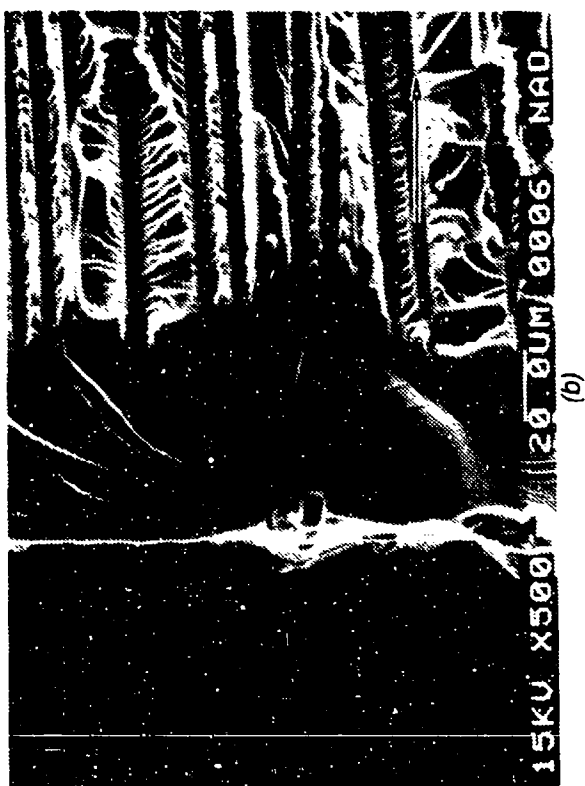
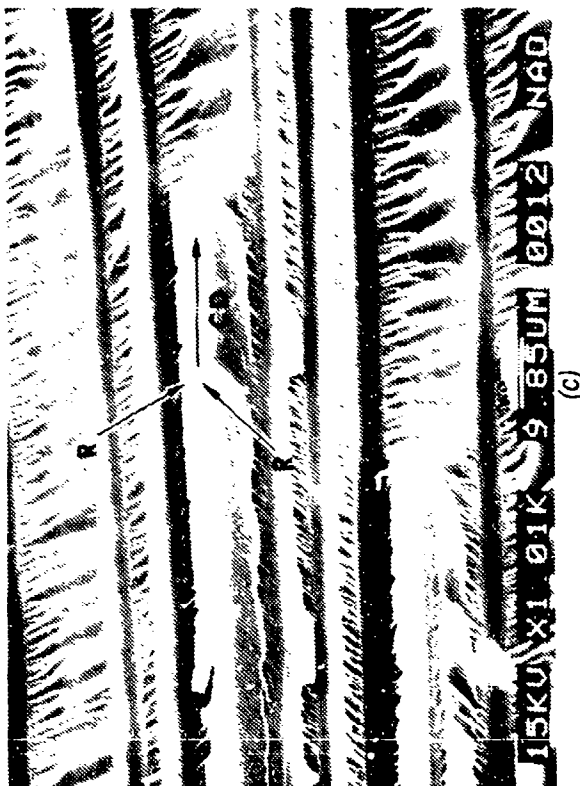
Figure 2-88. Optical and SEM Photographs of Mode II ENF Shear Interlaminar Fracture in Undercured Gr/Ep - [0]_{24T}
 (a) Macrophotograph of Fracture
 (b) Initiation Site in Region I
 (c) River Patterns (R) in Region I

CD = Crack-propagation direction

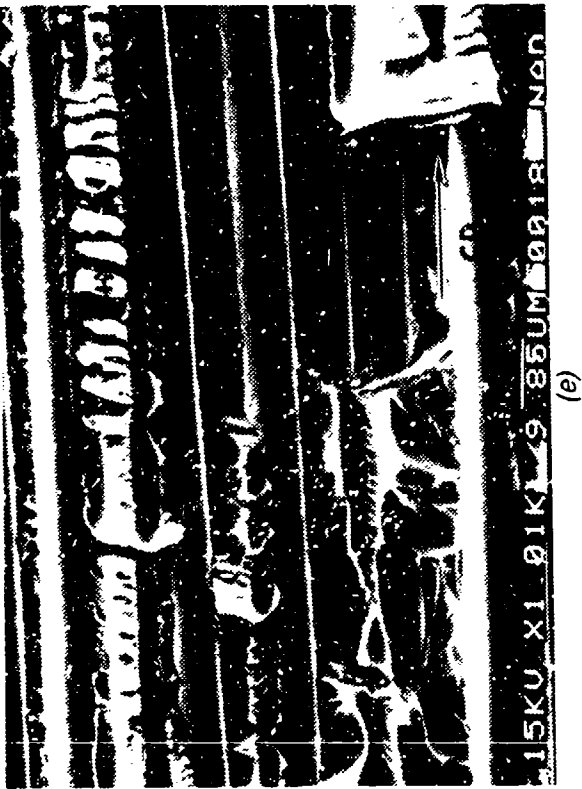
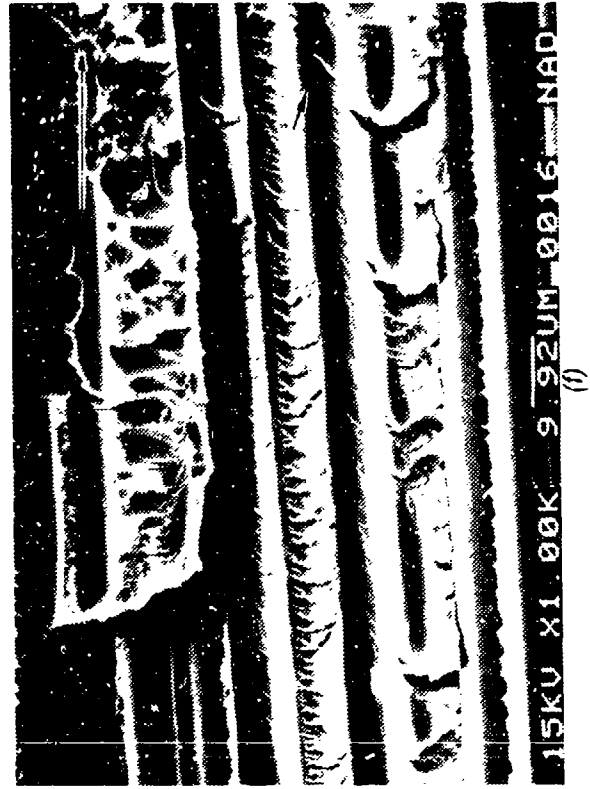
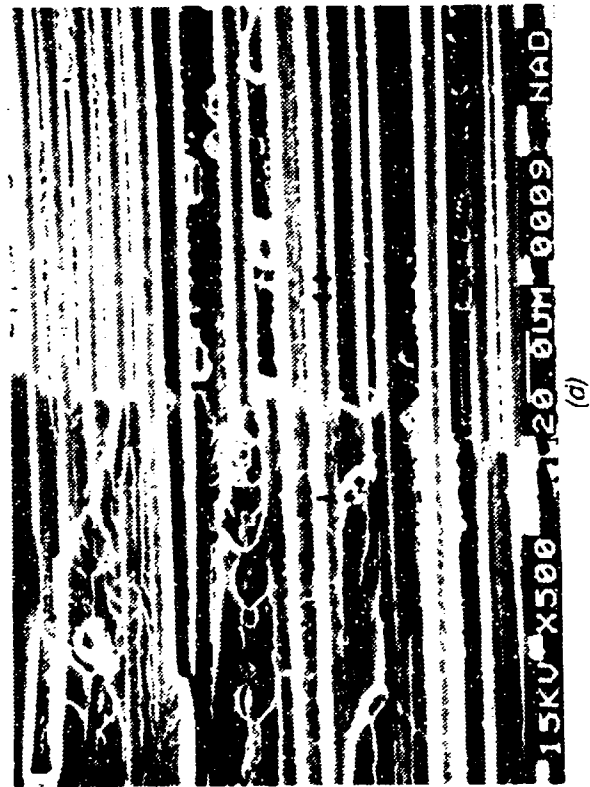
Figure 2-88. (Continued)
 (d) Region I/II Interface
 (e) Hackles (H) and Scallops (S) in Region II
 (f) V-Shaped Tears (Arrow) in Region II

CD = Crack propagation direction

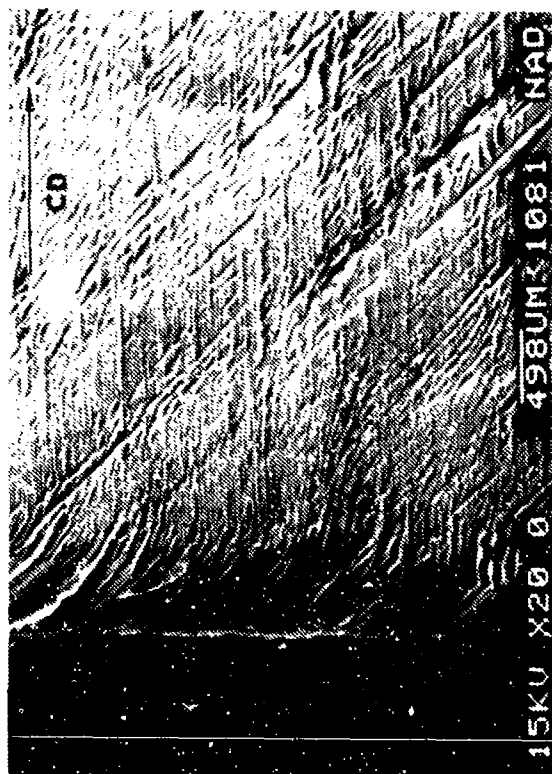
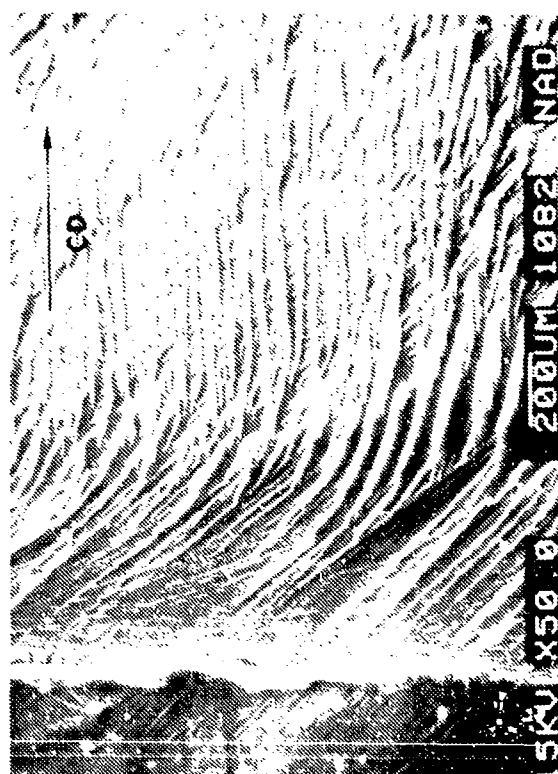
Figure 2-89. Optical and SEM Photographs of Mode II ENF Shear Interlaminar Fracture in Undecured Gr/Ep - [+45/0/-45]_s
 (a) Macrophotograph Showing Regions I, II, and III
 (b) Local Initiation sites in Region I
 (c) River Patterns in Region I

CD = Crack-propagation direction
